NIST-IR 6118

Metallurgy of the *RMS Titanic*

Tim Foecke
Metallurgy Division
National Institute of Standards and Technology

February 4, 1998

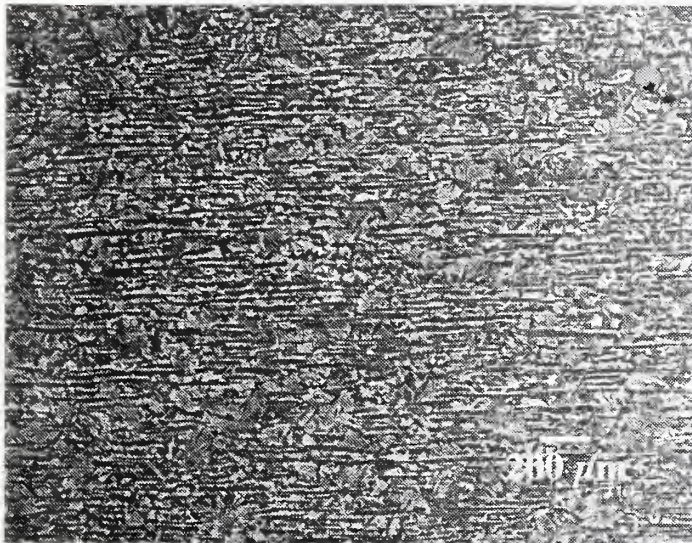
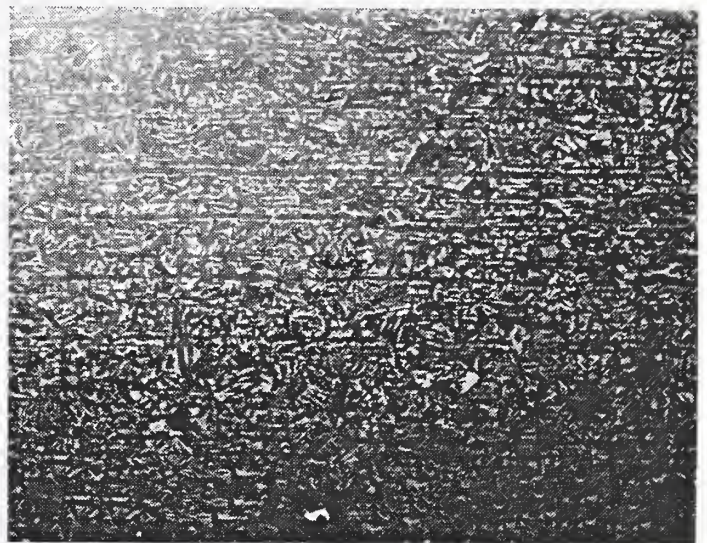
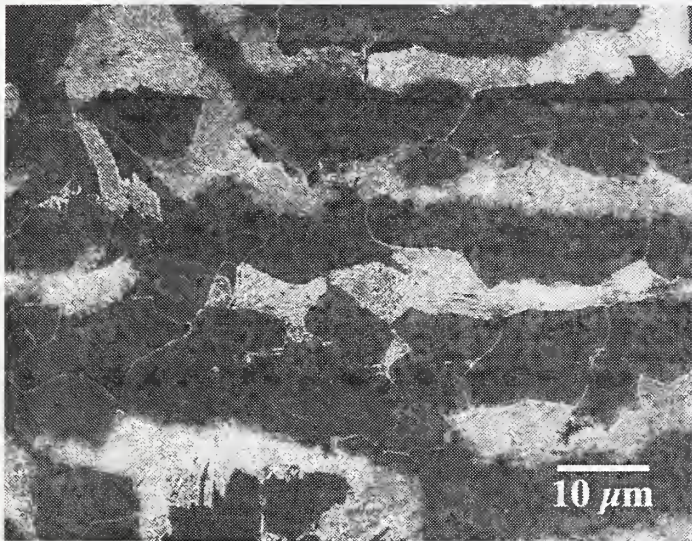
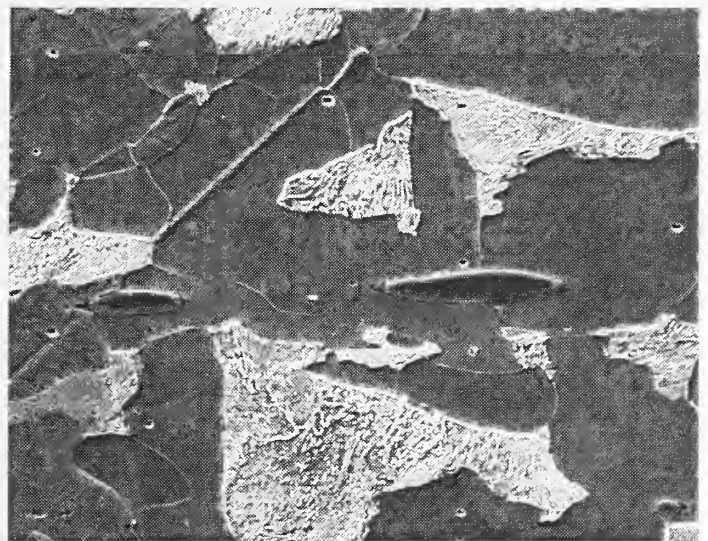
Steel samples of all three orientations orthogonal with respect to the rolling plane were polished and etched to reveal the microstructure. A ferrite-pearlite microstructure was seen, with large ferrite grains (ASTM number = 4-5, 100 μm to 130 μm equivalent diameter) and large, coarse pearlite colonies (roughly 0.2 μm lamella thickness, but quite variable). The microstructure shows a large amount of banding in the rolling direction. MnS and oxide particles are evident throughout the material, and were quite large, occasionally exceeding 100 μm in length. The MnS particles were deformed into lenticular shapes instead of being melted into stringers. Given the lack of rare-earth additions to increase the sulfide melting point (see table 2), this indicates a low rolling temperature. The large grain size and coarse pearlite are consistent with air-cooling of the rolled

plate, with no evidence of quenching or normalization treatments evident. All of this evidence is consistent with the production of this plate in a low speed rolling mill, as was the norm in turn-of-the-century Ireland.

Figure 1: Scanning electron microscope image of the polished and etched longitudinal sections of steel from the hull of the *Titanic*, and for comparison a modern hot-rolled 25 mm (1") AISI 1018 plate. Note the differences in grain size, pearlite lamella spacing, and MnS particle sizes.

Trends have been found relating microstructural characteristics of mild steel with ferrite/pearlite microstructures to fracture toughness. In general, larger ferrite grain sizes and pearlite colonies give lower toughnesses [17]. There is a body of work in the literature, for example the analysis of Ritchie, Knott and Rice [18] that the size, shape and distribution of carbides in mild steel is a dominant factor in determining the shape and location of the brittle-to-ductile transition temperature (BDTT). Since the steel from the hull appears to have been air-cooled and unannealed, most of the carbon not in matrix solid solution is tied up in carbide lamella in the pearlite. It was not possible in either the SEM or TEM to find precipitated particle carbides in the steel. So the carbide size that would be controlling fracture behavior would be that in the pearlite, and thus a coarser pearlite lamella spacing would cause a higher transition temperature.

A finer microstructure, both in terms of grain size and in pearlite lamella spacing, would have exhibited a significantly higher transition temperature at this composition. This could have been obtained by rolling the steel at a higher speed and temperature, then subjecting the plate to a quench and normalization anneal. However, the concept of notch sensitivity of iron-based alloys was little understood, and the first quantitative ways to begin to evaluate the fracture toughness of a material, among them the Charpy V-notch test [21], was only devised in the five or so years before the

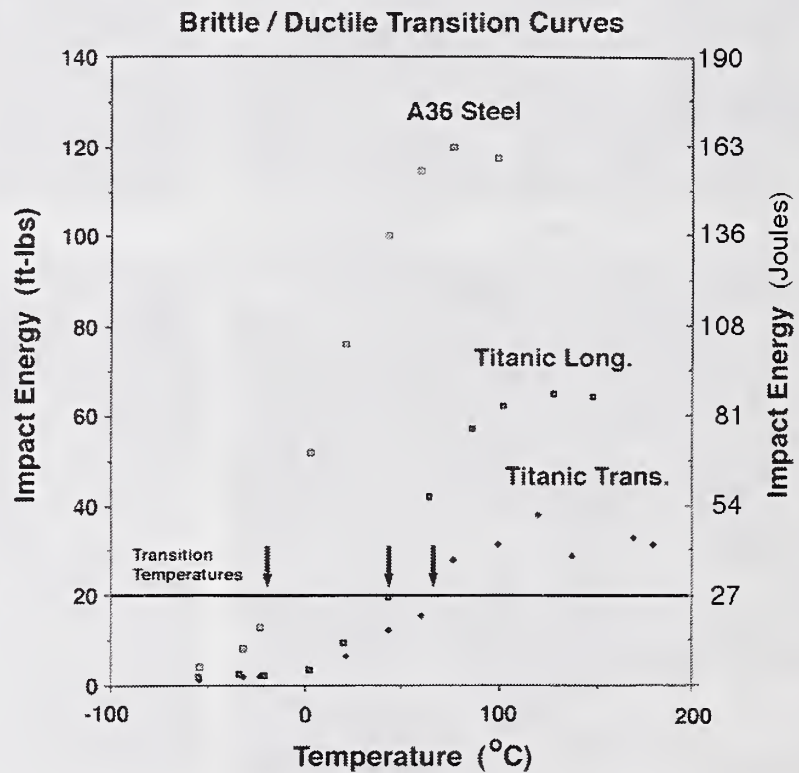
The data produced from tensile tests performed on steel recovered in 1996 [5] and 1991 [2] is shown in Table 1. The uncertainty in this data is unknown. These values are consistent with the design requirements of "15-20 tonnes per inch squared" as specified by Harland and Wolff (the shipbuilder who constructed *Titanic* in Belfast in 1911 [4]). Two groups of Charpy specimens were prepared such that in one group the long direction of the specimens were parallel to the longitudinal direction of the hull plate (LS) and in the second group the long axis of the specimen was parallel to the transverse direction (TL). The adjoining figure compares the experimental results from the Charpy impact test of the *Titanic* hull steel for the longitudinal and transverse rolling directions with a modern ASTM A36 mild steel [7]. Unfortunately for the purposes of a direct correlation of properties and microstructure, the comparison of mechanical behavior was made versus A36 steel, which is chemically nearly identical to AISI 1018 used in the microstructural comparison, but has a more specialized microstructure. Using 20 ft-pounds (27 J.) for the determination of the ductile-brittle transition temperature, the author [5] obtains a transition temperature of -15°C for the modern A36 steel, while the *Titanic* specimens yielded transition temperatures of $+40^{\circ}\text{C}$ for specimens in the longitudinal direction and $+70^{\circ}\text{C}$ for the transverse direction. The transition temperatures for the *Titanic* steel are much above the water temperature of -2°C at the time of the ship-iceberg collision [1].

Figure 2: A plot of the impact energy measured by the Charpy test versus temperature for two different orientations for the *Titanic* hull steel, as well as modern A36 (which is chemically and microstructurally very similar to AISI 1018). The transition temperature is marked for each series of samples, and is defined as that temperature where the sample exhibited 20 ft-lbs (27 J.) of energy. Data from reference [5]. The uncertainty in the data is unknown.

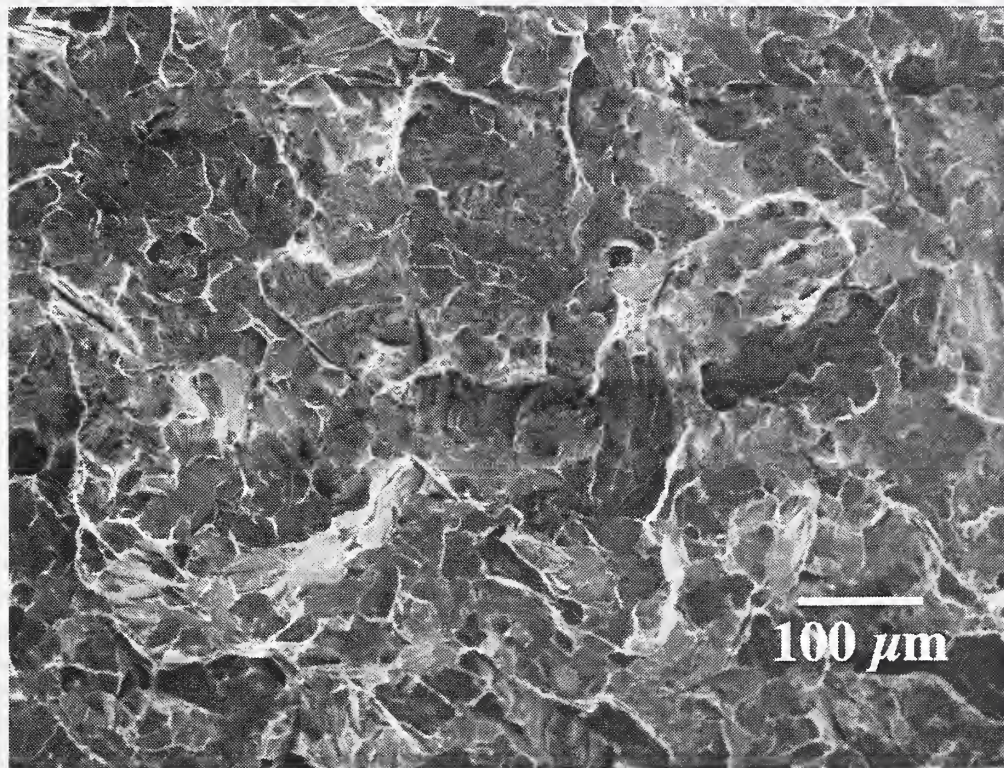
Fracture surfaces cut from the Charpy test specimens tested from the 1996 plate were examined in the scanning electron microscope. Fracture was entirely transgranular (figure 3), with no evidence of fractured grain boundaries. This is significant, in that if the cause of limited fracture ductility of the steel (as evidenced by the absence of microvoids) had been sulfur embrittlement, we would expect sulfur segregation to the grain boundaries and intergranular fracture facets. At ice-brine temperatures, the fracture was nearly entirely brittle, with the ductile portion of the fracture surface estimated to be less than 5 percent (figure 4). Cleavage patches on the surface, made up of 4 to 15 cleaved grains, were seen to originate at fractured MnS particles, as evidenced by tracing river lines on the facets. This indicates that in some cases the MnS particles acted as initiators, but the incidence of these nucleated patches amounted to less than 10% of the surface area of the Charpy bar fracture surface.

Figure 3: SEM fractograph of Charpy bar fracture surface (LT) from a sample fractured at 0° C. Note the presence of cleavage facets and absence of fracture grain boundaries. One or two cleavage patches nucleated by MnS particles can be identified in this image.

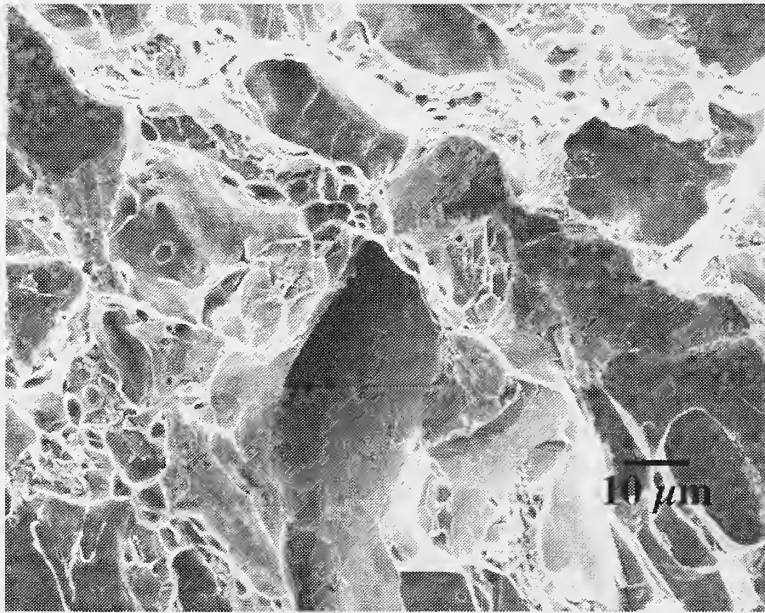
Figure 4: SEM fractograph of Charpy bar fracture surface from a sample fractured at 0° C. Note presence of ductility along ridges. This micrograph contains the largest amount of plasticity observable on the surface in one area of the fracture surface of this sample.

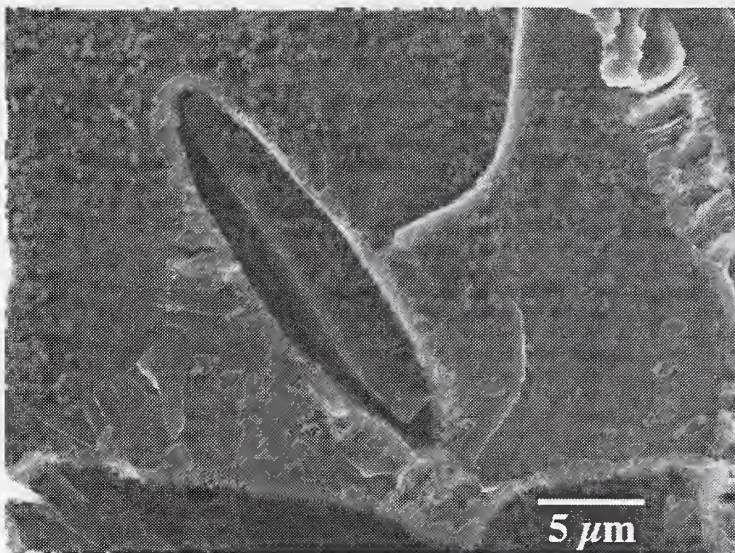
Figure 5: SEM fractograph showing the MnS particle that fractured and nucleated a patch of 15 cleaved grains. This was determined by tracing river lines within the patch. Note the lenticular shape of the particle, the cleavage river lines emanating from the particle, and the fractured course pearlite colony in the upper right corner.

The presence and large size of the MnS particles are considered deleterious to fracture resistance, as they act as crack initiators within the steel at temperatures near the lower shelf [19]. It was seen that the plate recovered in 1996 exhibited 5% ductile fracture during Charpy tests at ice-brine temperatures, and that MnS particles, upon examination of the fracture surface, nucleated a few patches of cleavage. However, the plate recovered in 1991 was 100% brittle even at room temperature [20], placing it firmly in, not near the lower shelf regime. Thus MnS particles would have little to no effect on toughness in this plate. The presence of MnS particles and their effect on crack growth have been found to be much more important at high temperatures than lower temperatures. Their effect on the fracture behavior of both the material in this study as well as the 1991 study [2] are considered negligible. Although cleavage patches have been identified on the fracture surface as having come from the fracture of a MnS particle, and thus the formation of a process-zone would have begun, the occurrence of this was relatively rare. It is believed that the fracture mechanism that controlled at -2°C would have been weakest-link [18], where the first fractured microstructural feature would have precipitated failure. And as the population of large carbides, in the form of thick pearlite lamella, is many times that of large sulfides, it is more likely that a fractured carbide would precipitate failure.

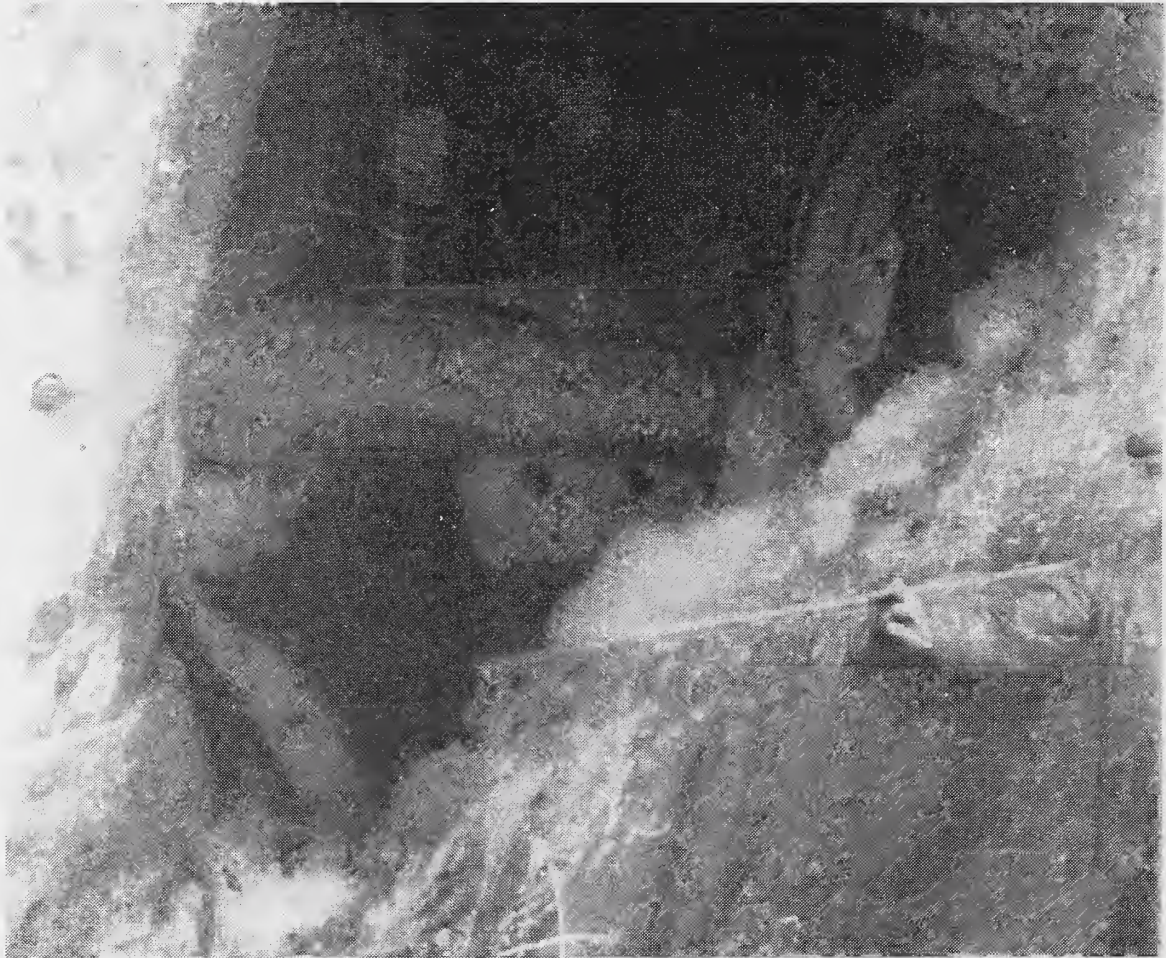
ship with the iceberg at 20+ knots would have occurred at strain rates more in line with a Charpy impact test. At this rate, the steel would exhibit more brittle behavior. Additional evidence comes from photographs of damage to the *Titanic's* sister ship, *RMS Olympic*, after collision in Belfast harbor with a Royal Navy cruiser, *HMS Hawke* [25] (figure 5). A close examination of the photos show considerable bending of the plates around the hole, while reports of the physical damage include a mention of a triangular piece of hull that fractured into the ship. This would be consistent with a high strain rate impact causing fracture, and then progressively slower deformation as the two ships pressed together, causing bending instead of cracking.

Figure 6: A close-up of the damage to the *RMS Olympic* due to collision with the *HMS Hawke* in the Solient in 1911. Note the man for scale. A considerable amount of plasticity in the hull plates is indicated by the bending and twisting seen in the picture. Note missing rivets. Photo from [25].

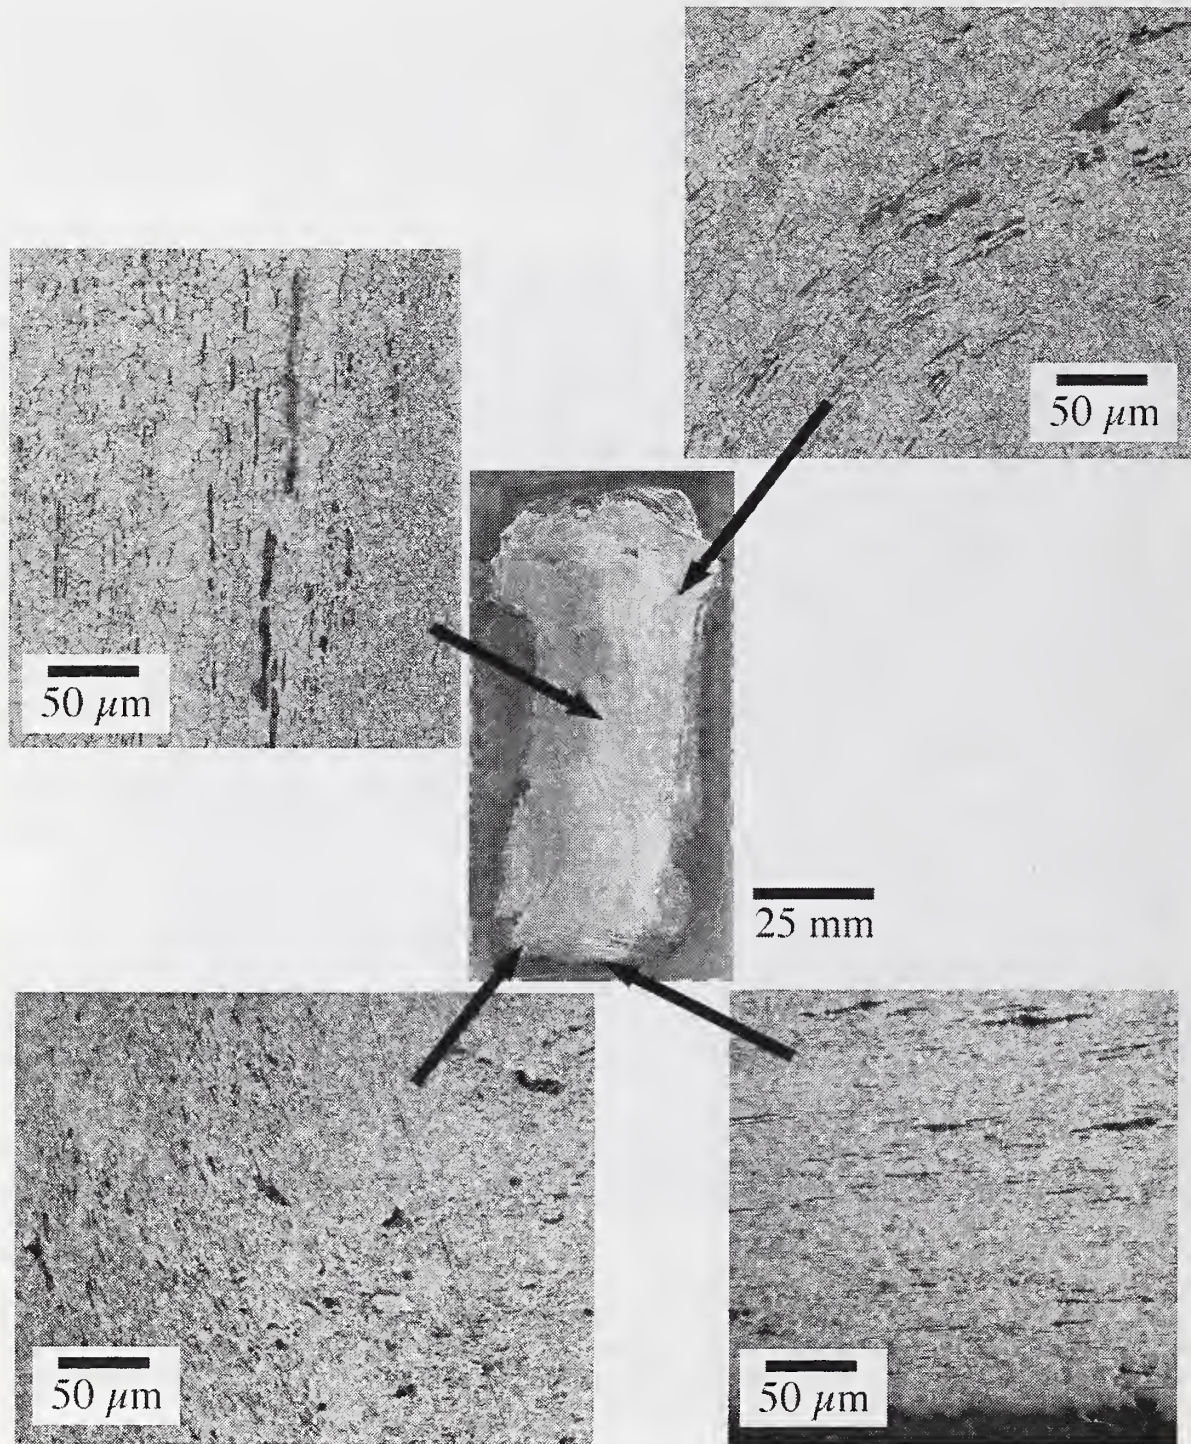
These rivets were made of wrought iron, which consists of a relatively pure iron matrix containing 2-3% (by volume) iron silicate slag. A micrograph of the structure can be seen in figure 7. Quantitative metallography was performed on a cross-section of a hull rivet that had been cut and polished. This showed that this rivet contained 9.3% +/- 0.3% slag on average, which is more than 3 times the amount normally expected in wrought iron [27]. This slag had an almost bi-modal-type distribution of sizes, ranging from a large amount in very long stringers (>200 μm long) to a large number of small oblate spheroid particles (1 μm to 5 μm diameter).

The two hull rivets in possession have been sectioned and examined. Both exhibit the above-mentioned orientation distribution of slag stringers within the rivet, an increased amount of incorporated slag, and are both missing the inner head. These metallurgical factors would have degraded the mechanical performance of the rivet. If additional samples are obtained during an expedition planned for August of 1998, further work will be performed to determine if this was a major factor in the sinking of the ship. Rivets from an intact section of a lap joint will be sectioned to see if rivets that did not fail contain elevated slag levels and transversely-oriented slag stringers. It is important to reiterate that only two rivets have been sectioned to date, out of 3,000,000, some minority percentage of which held the hull together.

Figure 7: Montage of micrographs showing the orientation of silicate slag at various locations within a cross-section of a *Titanic* hull rivet. Note that in the upper pre-formed head (formed onto a hot rod of wrought iron prior to cutting the rivet to length), the slag spreads out evenly into the head like the branches of a tree. At the bottom, where the inner head popped off, very near the fracture surface the stringers are oriented perpendicular to the tensile axis. This occurred presumably when the inner head was formed.

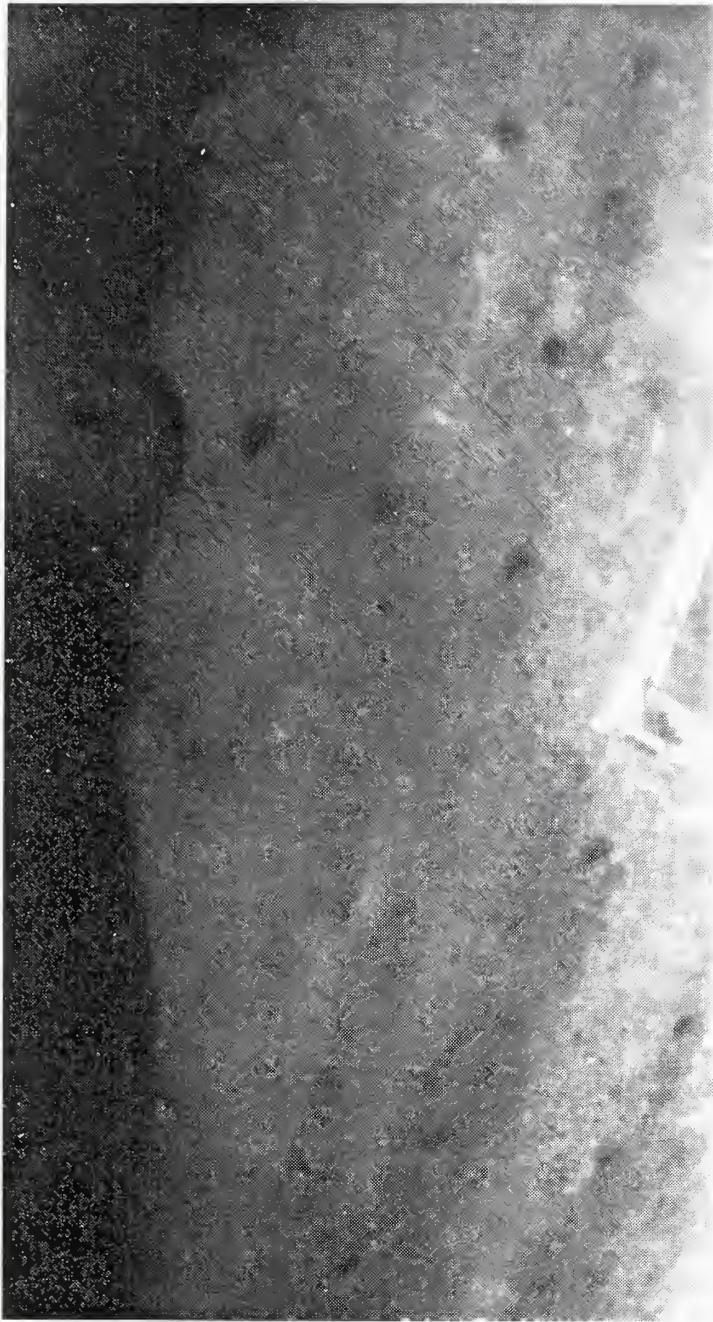
Upon impact, these rivets might have a tendency to pop out of their holes after losing the interior head. This is evidenced by both the rivets in possession, which are missing interior heads, and by the higher magnification of the damage to *RMS Olympic* after collision with the *Hawke* (figure 8). If you look at the photograph, dozens of rivets around the hole are missing. Loss of rivets, and the resultant parting of seams and water leakage, is believed to be the main occurrence that caused the sinking of the *Titanic* [7].

Figure 8: Blowup of damage to *Olympic* after collision with *HMS Hawke*. This image has undergone a considerable amount of digital image processing to bring out the empty rivet holes. On the entire image after processing, one can identify in excess of 50 rivets missing from the immediate area of the impact. Image from [25].

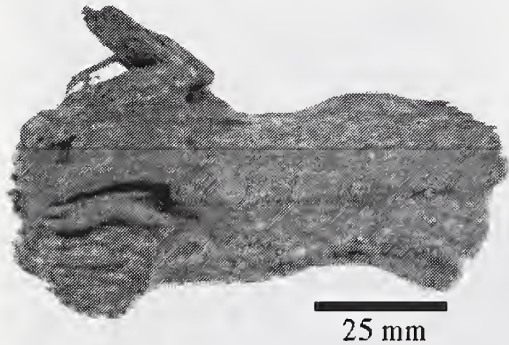
material. This represents a smaller amount of deflection of the hull plate applying the stress through leverage against the supporting rib inside the ship. High residual stresses would increase the tendency of rivets to “pop” during collisions. The presence of high residual stresses in *Titanic* rivets can be seen in a badly-corroded bulkhead rivet, seen in figure 9. The head of the rivet has exfoliated and the slag stringers have spread, driven by residual stress during stress corrosion cracking and dissolution of the ferrite.

Figure 9: Bulkhead rivet from RMS Titanic. Note the portion of the head that exfoliated during corrosion of the ferrite matrix of the wrought iron, under the influence of the residual stress in the rivet.
